TOWN HALL FACILITY NEED ASSESSMENT

AUGUST 20, 2025

Facility Condition Assessment

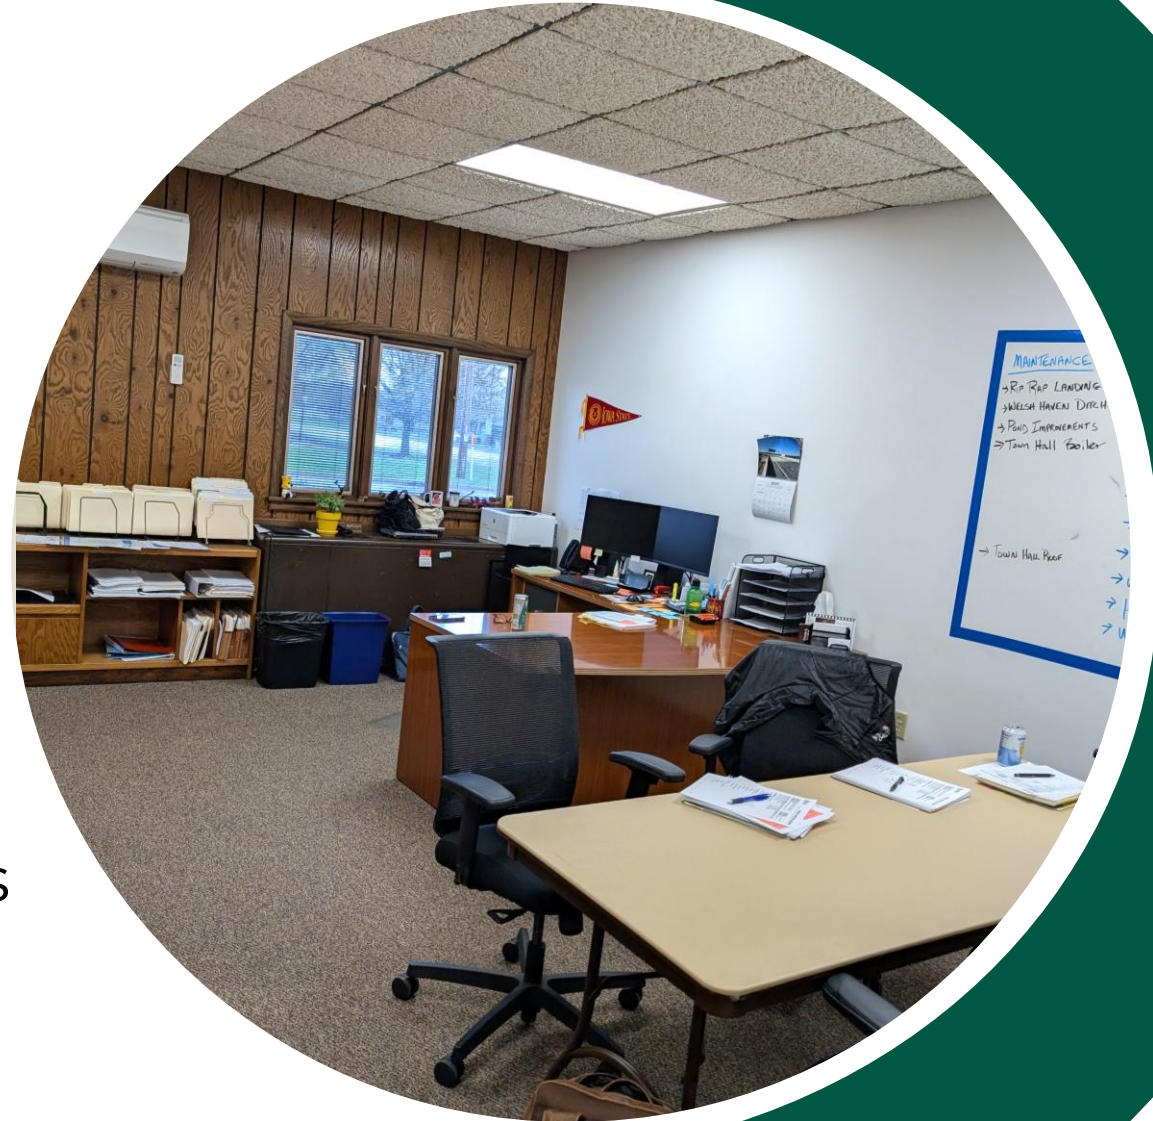
Key Observations

- Accessibility:
 - Non-compliant doors/hardware
- Security:
 - No entry control
 - Limited visibility for staff
 - Public access to multiple areas
- Interior Finishes:
 - Damaged flooring, ceiling, doors
 - Possible hazardous materials
 - Antiquated finishes

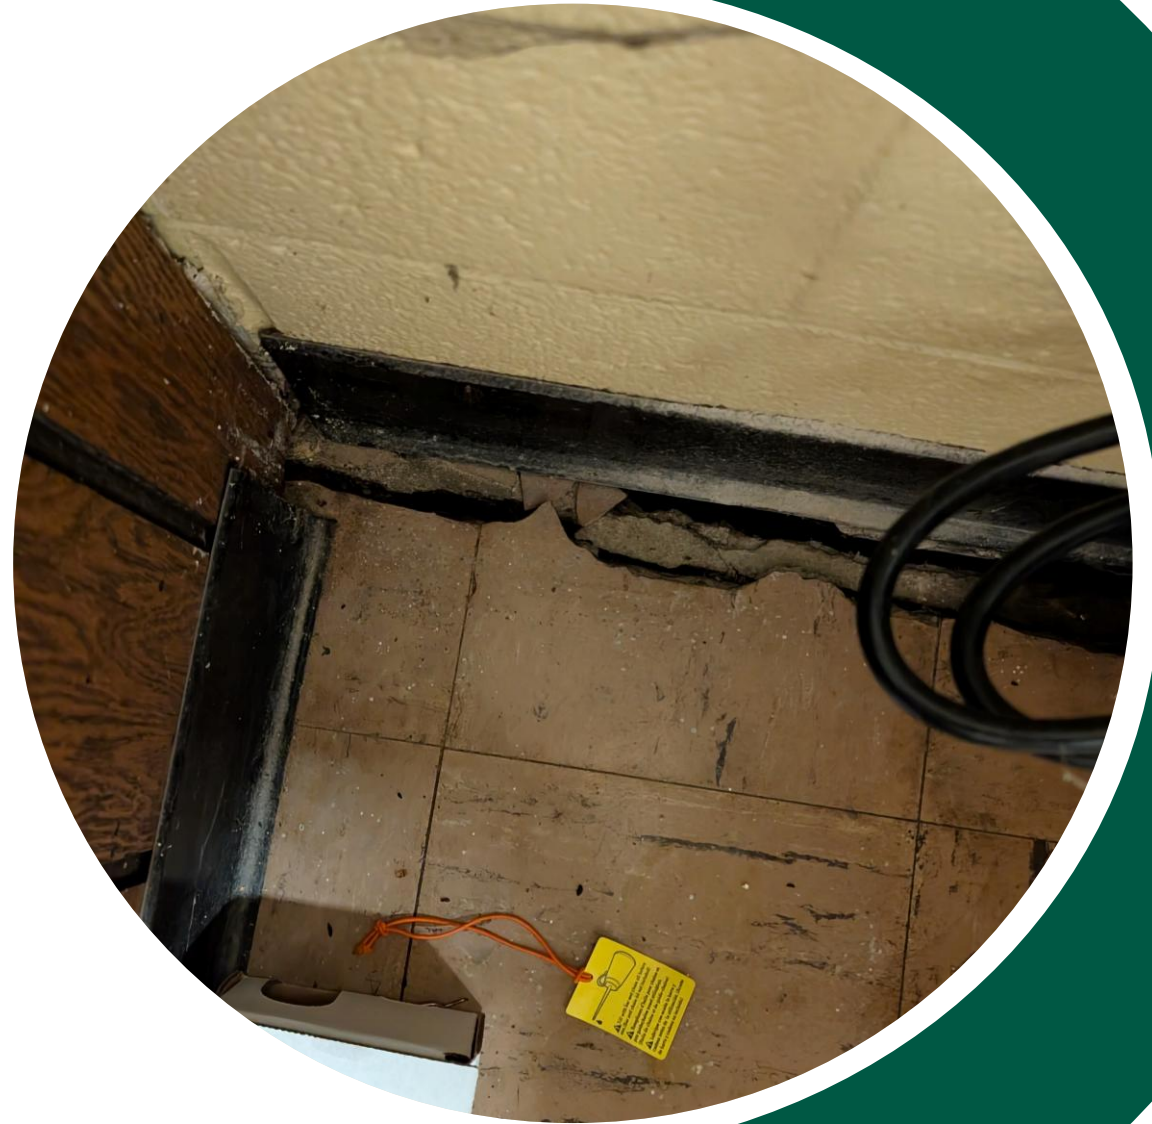
Building Envelope Issues

- Inadequate wall insulation
- Single-pane windows
- Roof leaking
- Foundation separation in southeast corner
- Brick façade moisture infiltration

- **Minimal Upgrades to Existing Building**
- New efficient forced air heating system
- Roof repair / replacement
- Envelope repair:
 - Tuckpointing
 - Foundation separation
- New Public Works garage
- Cost:
 - Construction: \$934,000
 - Total: \$1,280,330
- Timeline: 15 months
 - Design: 6 months
 - Bidding/Contracts: 3 months
 - Construction: 6 months

- **Full renovation of Existing Building**
- New efficient forced air heating system
- Envelope repair:
 - New Roof
 - New Windows
 - Tuckpointing
 - Foundation separation
- Security updates
- Reconfigure layout
- New Public Works garage
- Cost:
 - Construction: \$1,344,000
 - Total: \$1,897,040
- Timeline: 15 months
 - Design: 6 months
 - Bidding/Contracts: 3 months
 - Construction: 6 months

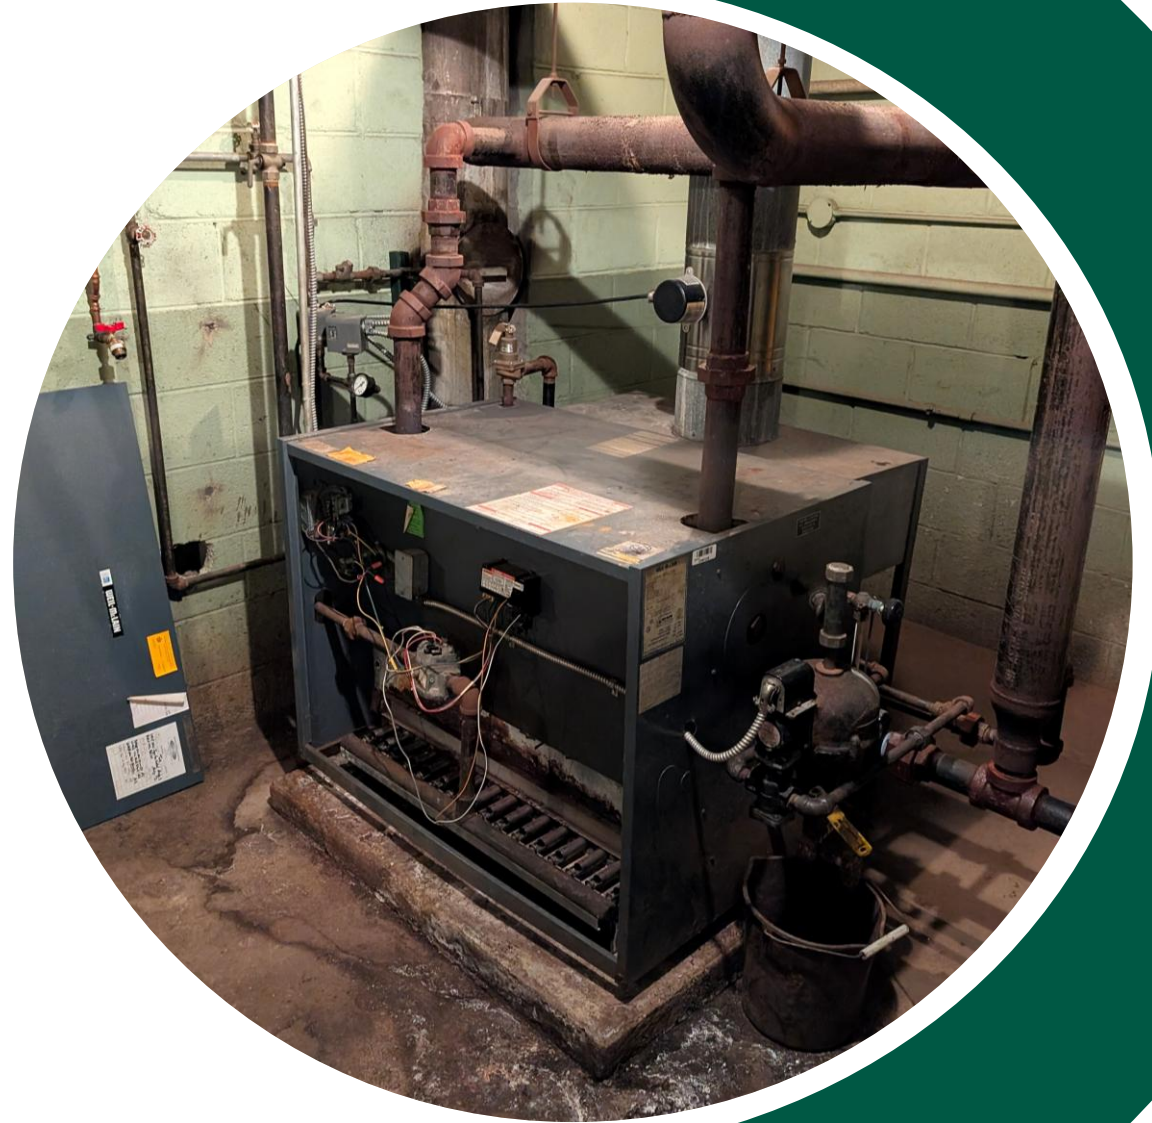
Building Systems

- Heating: boiler beyond life expectancy
- Electrical: outdated but functional
- Lighting: LED in good condition
- Plumbing: antiquated fixtures

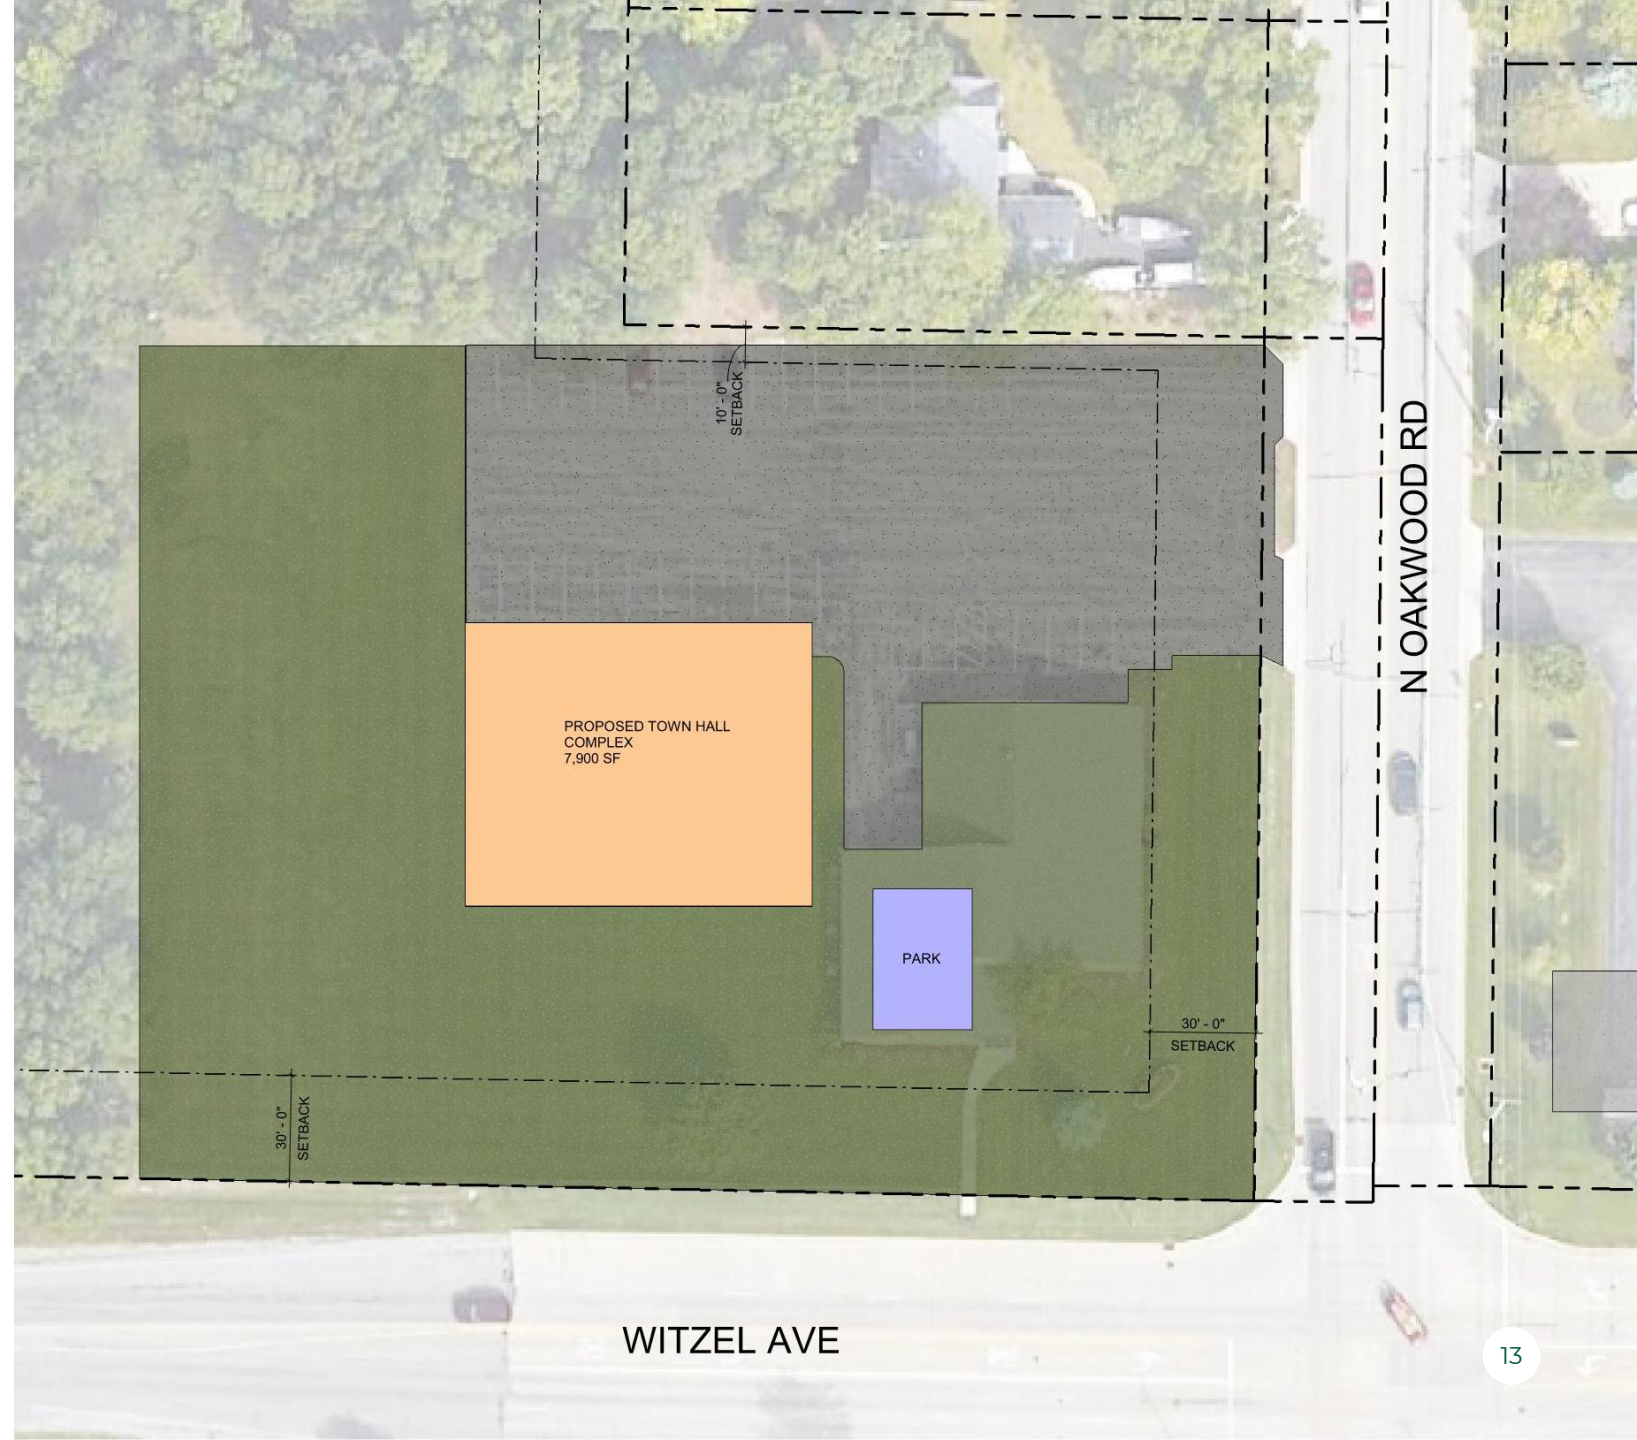
Option 3

- **New facility at current site**
- New 7,900 square foot Town Hall with Public Works Garage
- Demo existing building
- Cost:
 - Construction: \$2,336,100
 - Total: \$3,335,304
- Timeline: 21 months
 - Design: 6 months
 - Bidding/Contracts: 3 months
 - Construction: 12 months

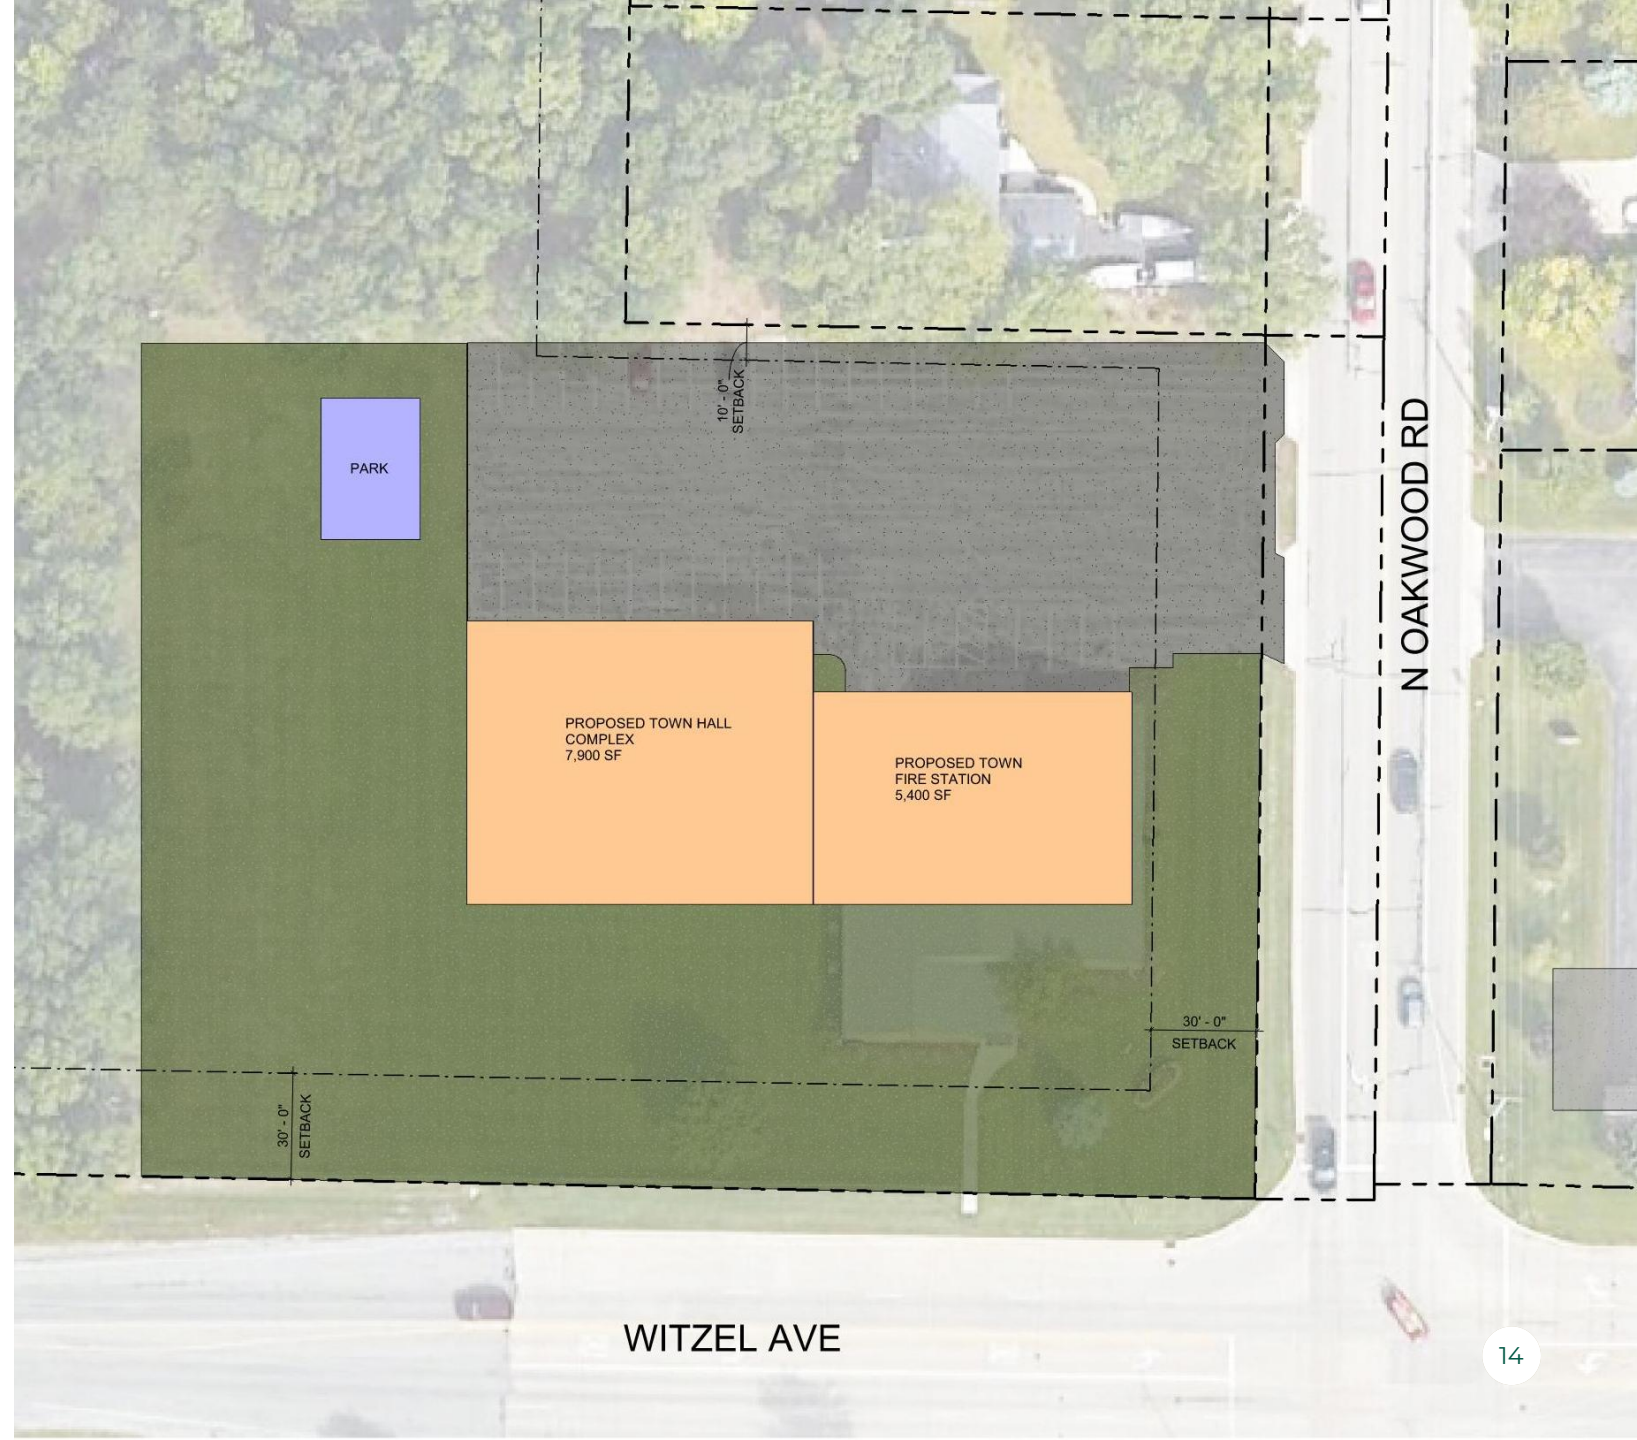
Option 3A

- New facility at current site **with Fire**
- Option 03
- Plus, new **5,400 square foot Fire Station**
- Cost:
 - Construction: \$3,429,250
 - Total: \$4,907,828
- Timeline: 25 months
 - Design: 6 months
 - Bidding/Contracts: 3 months
 - Construction: 16 months

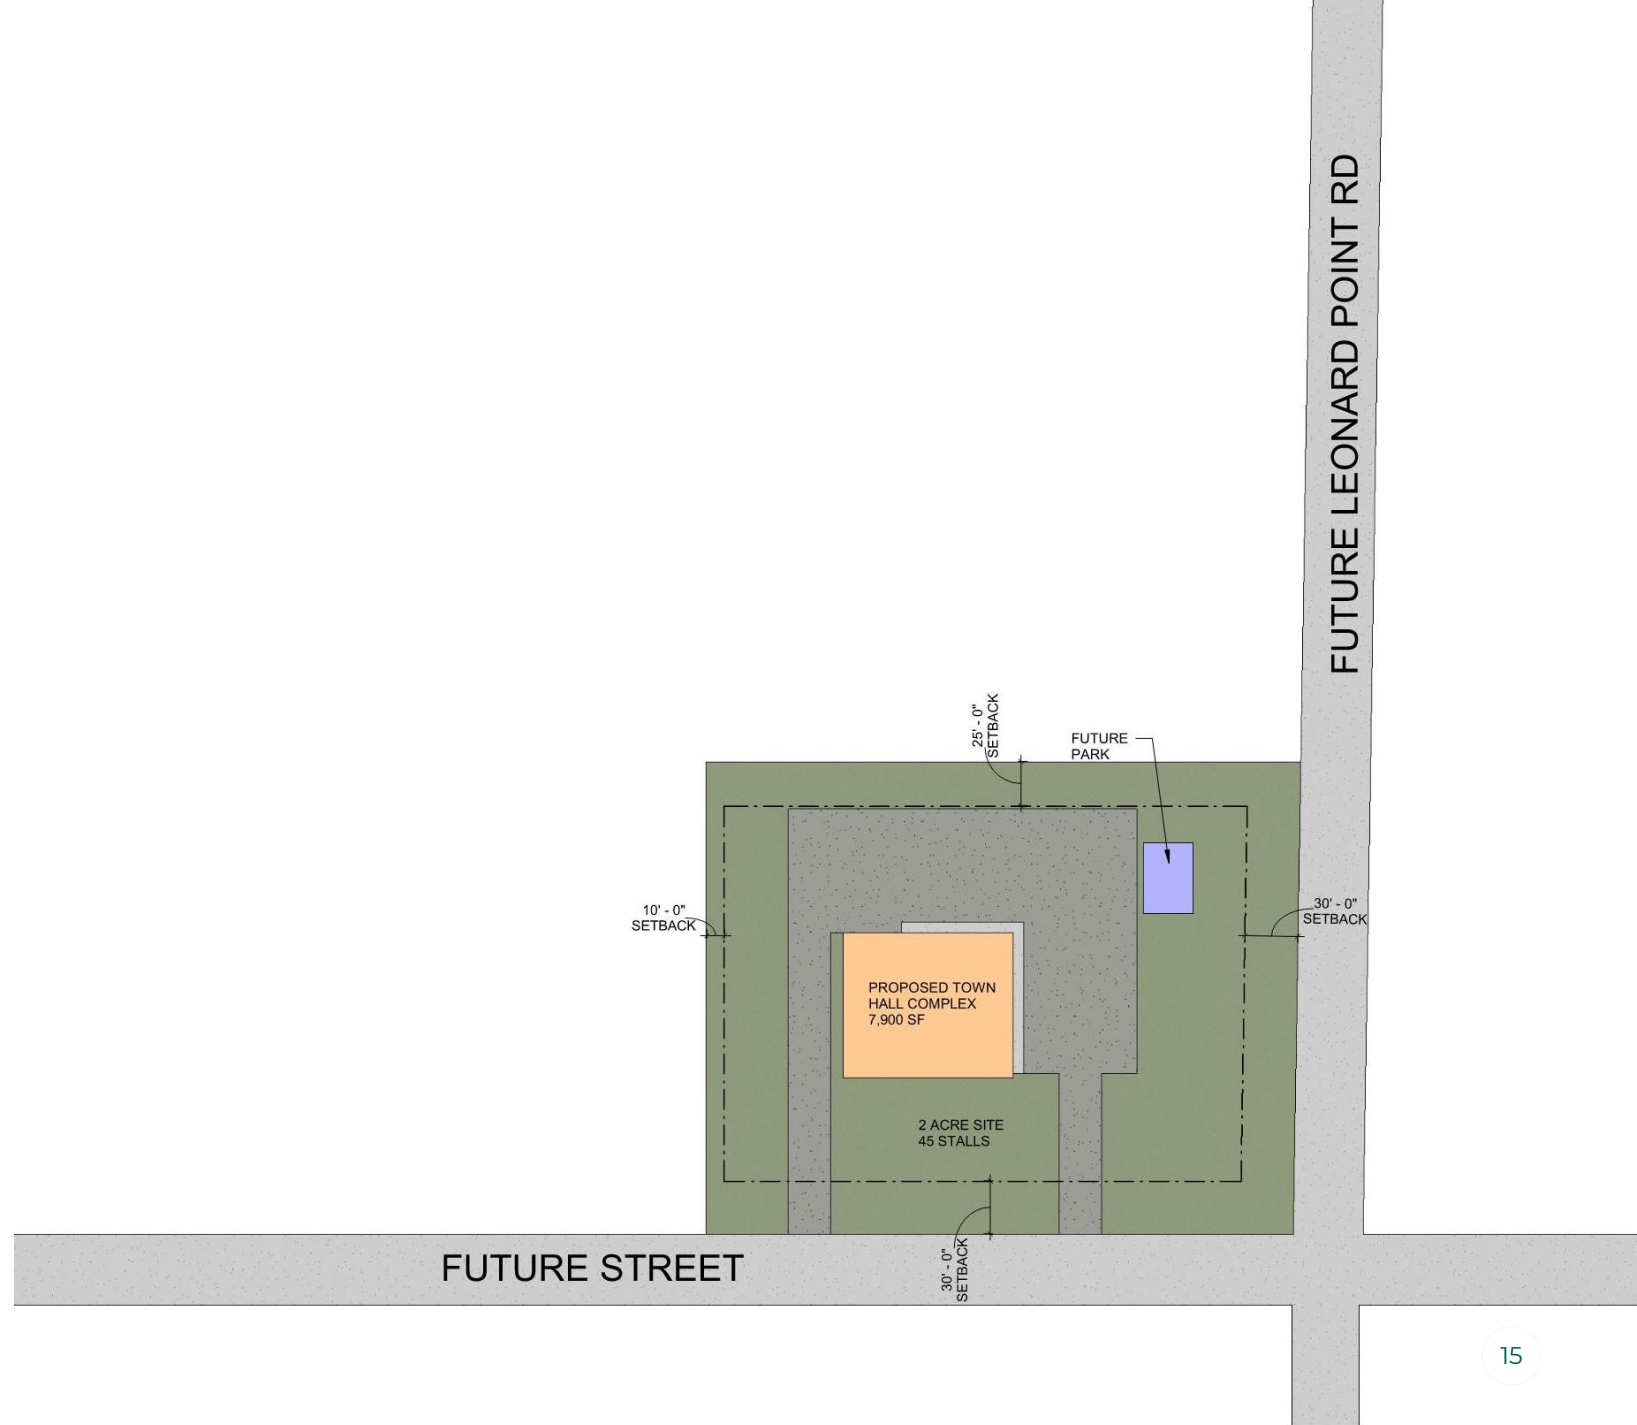
Option 4

- **New facility at new site**
- New 7,900 square foot Town Hall with Public Works Garage
- Centralized in future Town boundaries
- Sale of existing building and sale/develop of property
- Cost:
 - Construction: \$2,351,500
 - Total: \$3,377,403
- Timeline: 18 months
 - Design: 6 months
 - Bidding/Contracts: 3 months
 - Construction: 9 months
